Forensic Investigation of Abandoned GSIS Building in Manila

Tomas U. Ganiron Jr

This descriptive study aimed to conduct a forensic investigation of the abandoned Government Service Insurance System (GSIS) building in Manila. The fire incident caused the five-storey GSIS building to lose its strength due to heat in addition to the exposure of reinforcement due to weathering and deterioration of the structure as years pass by. The research has shown that the abandoned GSIS building has to change its use and to lessen its occupant capacity for the structure to serve its purpose and put into use again. Some interesting insights of the study are: a) Deterioration damage of concrete of the abandoned GSIS building is increasing as the years pass by; b) The abandoned GSIS building is still in serviceable condition in terms of its structural members; c) Steel corrosion and concrete deterioration are the major factors that affected the stability and integrity of structural members of the abandoned GSIS building in Manila; d) There is a difference between the design loads used in the GSIS building in Manila from the present design codes of National Structural Code of the Philippines (NSCP)

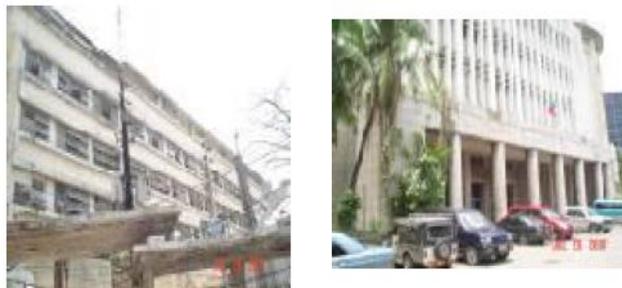
Figure 3. Abandoned GSIS building in Manila

The external part of the GSIS building shows damage, one of the causes is deterioration due to time, broken window glasses, collapsed small strip of concrete on the 5th floor, yet aside from the seemingly deteriorated facade the structure still stands firm [7]. With the help of this study, the possible causes of its abandonment and the remedial measures may be discovered for a potential reuse of this structure.

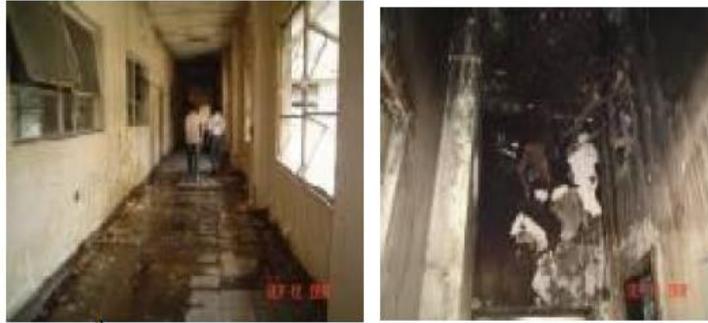
Figure 5. Fifth level hallway and portion of building affected by fire

On January 14, 2006, at around 5 pm, fire was spotted at the rear right portion of the 5th floor of the GSIS building [5, 6]. The fire was raised from 2nd alarm to 5th alarm in a span of 3 hours [6]. At the 4th hour, the fire was under control. The incident caused the five-storey building to lose its strength due to heat in addition to the exposure of reinforcement due to weathering and deterioration of the structure as years pass by [6].
